## Case Study

The customer was experiencing problems with Battery Acid Fumes during the recharging of forklift truck batteries. Our company was provided with a brief to overcome this workplace issue to create a healthier working environment for employees on site.

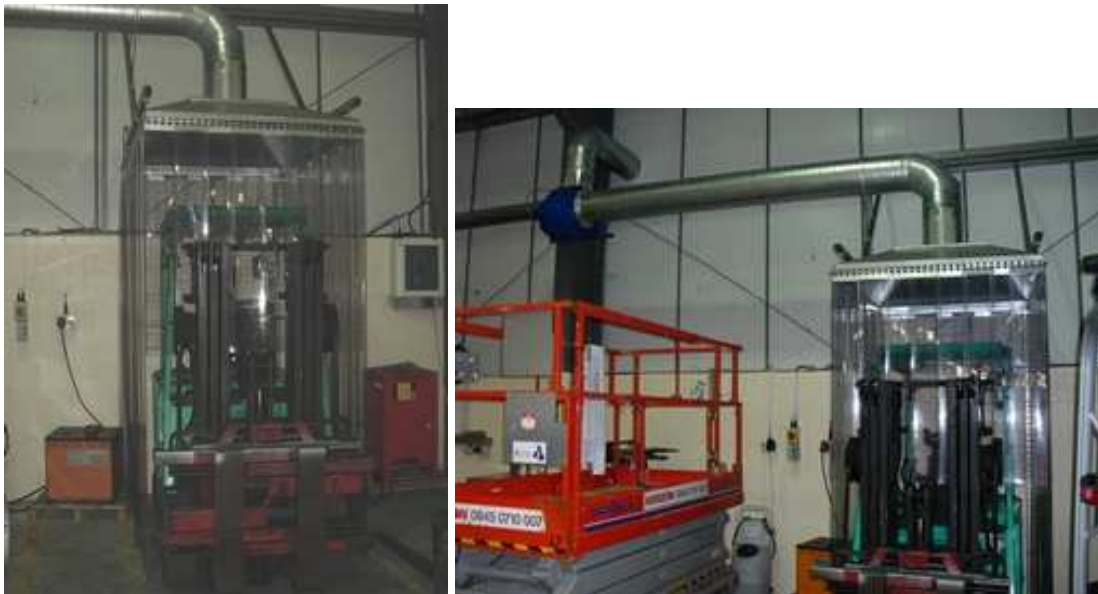
The point of extraction comprised of a fume canopy mounted on a galvanised steel frame, complete with PVC strip curtains.

Forklift trucks are reversed into position under the canopy and the PVC strip curtains drape around the forklift to envelope it and create an area of negative pressure. When the battery charger is switched on the rising fumes are captured by the air flow inside the enveloped area before being safely expelled to atmosphere.
