Case Study

We were contacted by a company responsible for railway infrastructure after an existing six figure Fume Extraction System in one of their workshops had underperformed since its original installation.

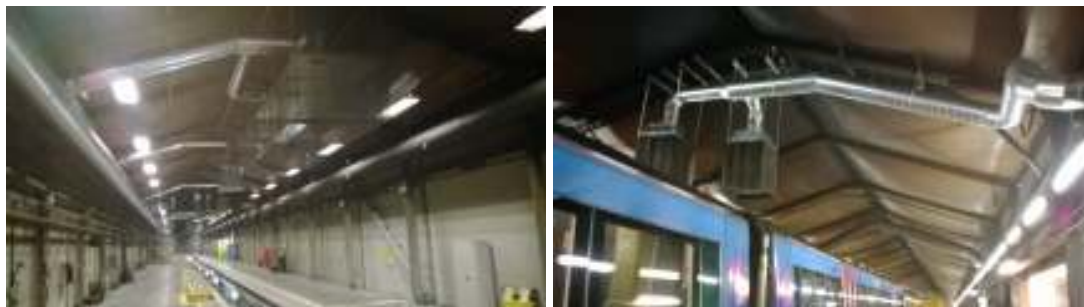
Our redesign encompassed Fume Extraction Hoods which were placed at marked stop points for the train carriages. The hoods are fitted with strip curtain to ensure full fume capture.
