Case Study

After failing its LEV Test we were asked to replace a Wood Dust Extraction System for an outdoor furniture manufacturer. The existing extractor was over fifteen years old and it had become more economic to replace the system due to low airflow.

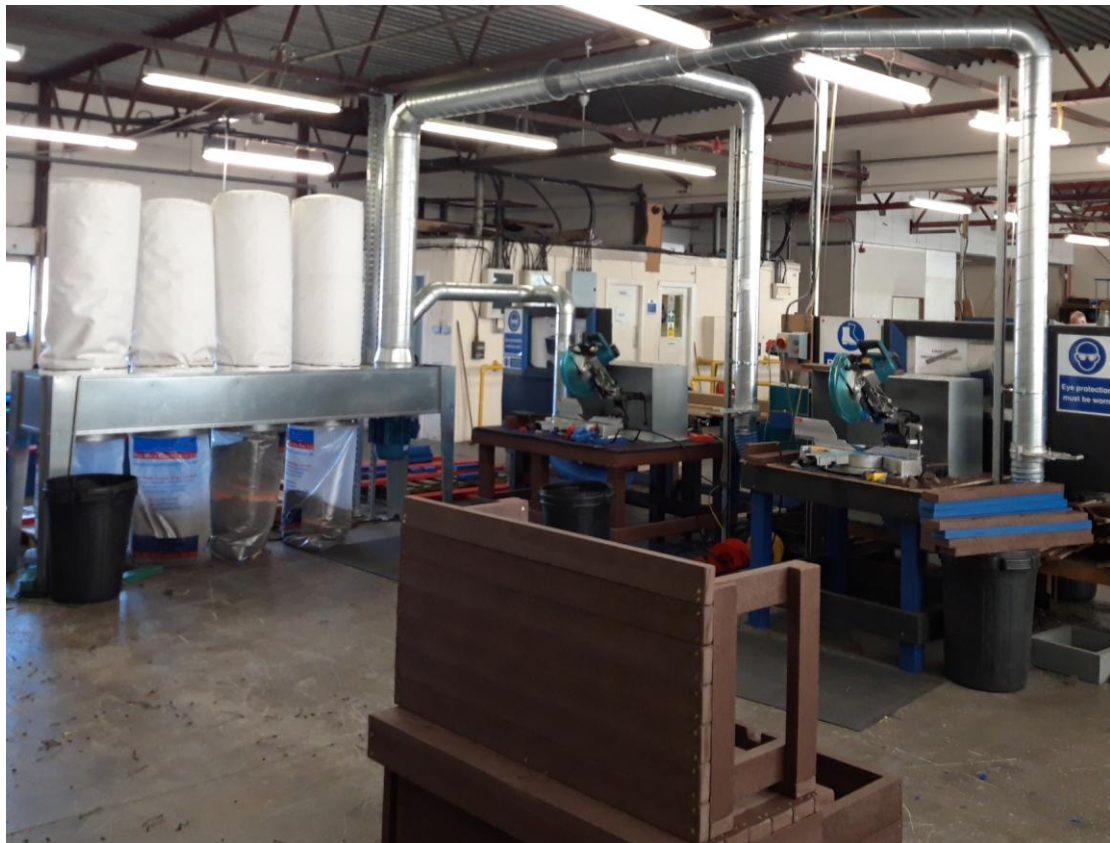
Three workstations are covered by chop saws and our design ensured that each workstation was protected from dust exposure. Each workstation comprised of a rear capture box and hopper to ensure that all dust was captured in line with HSE recommendations.

The four bag dust extractor was selected as the customer wanted 100% usage of all chop saws. Even flow through the extraction system was ensured via balancing dampers and transport velocities of dust through the ducting were in excess of HSE recommendations.
