## Case Study

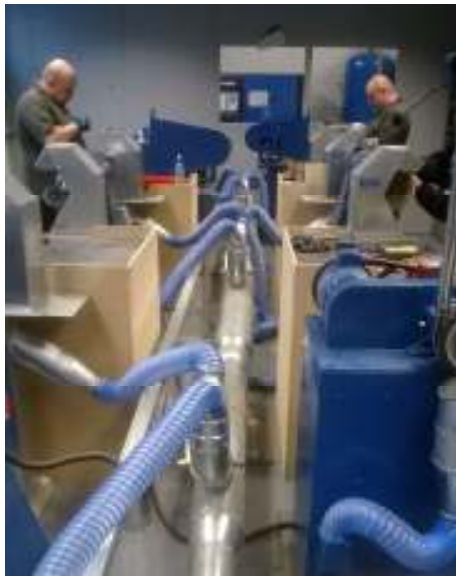
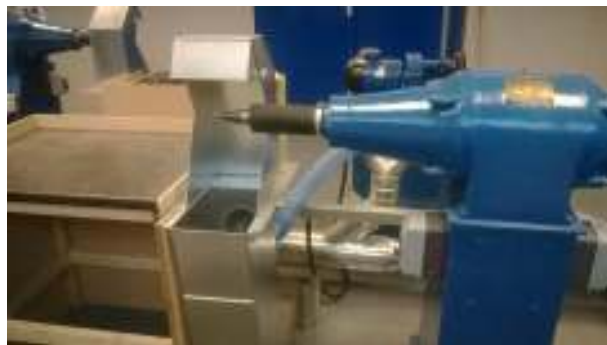
After attending site our calculations showed that although the Dust Extraction Unit was more than capable of completing the required job our competitor had calculated incorrect sized ducting runs for the system. This meant that the system was unable to handle the pressure put under it and so was performing badly.

Then through our calculations we installed correctly sized ducting which brought the pressure the system was under below its limits. Oversized ducting had been installed by our competitor which meant that dust was not being captured during the finishing process.

Firstly we moved the Dust Extraction Unit to another floor of the building as per the customers preference as the original installation location was inconvenient.

Our modifications have ensured that the system now performs as expected by the customer and has passed its annual LEV Test as stipulated in HSG258.
